National Transportation Safety Board Special Investigation Report  
Inspection and Testing of Railroad Tank Cars

PB92-917010  
NTSB/SIR-92/05

# **INSPECTION AND TESTING OF RAILROAD TANK CARS**

## **Special Investigation Report**

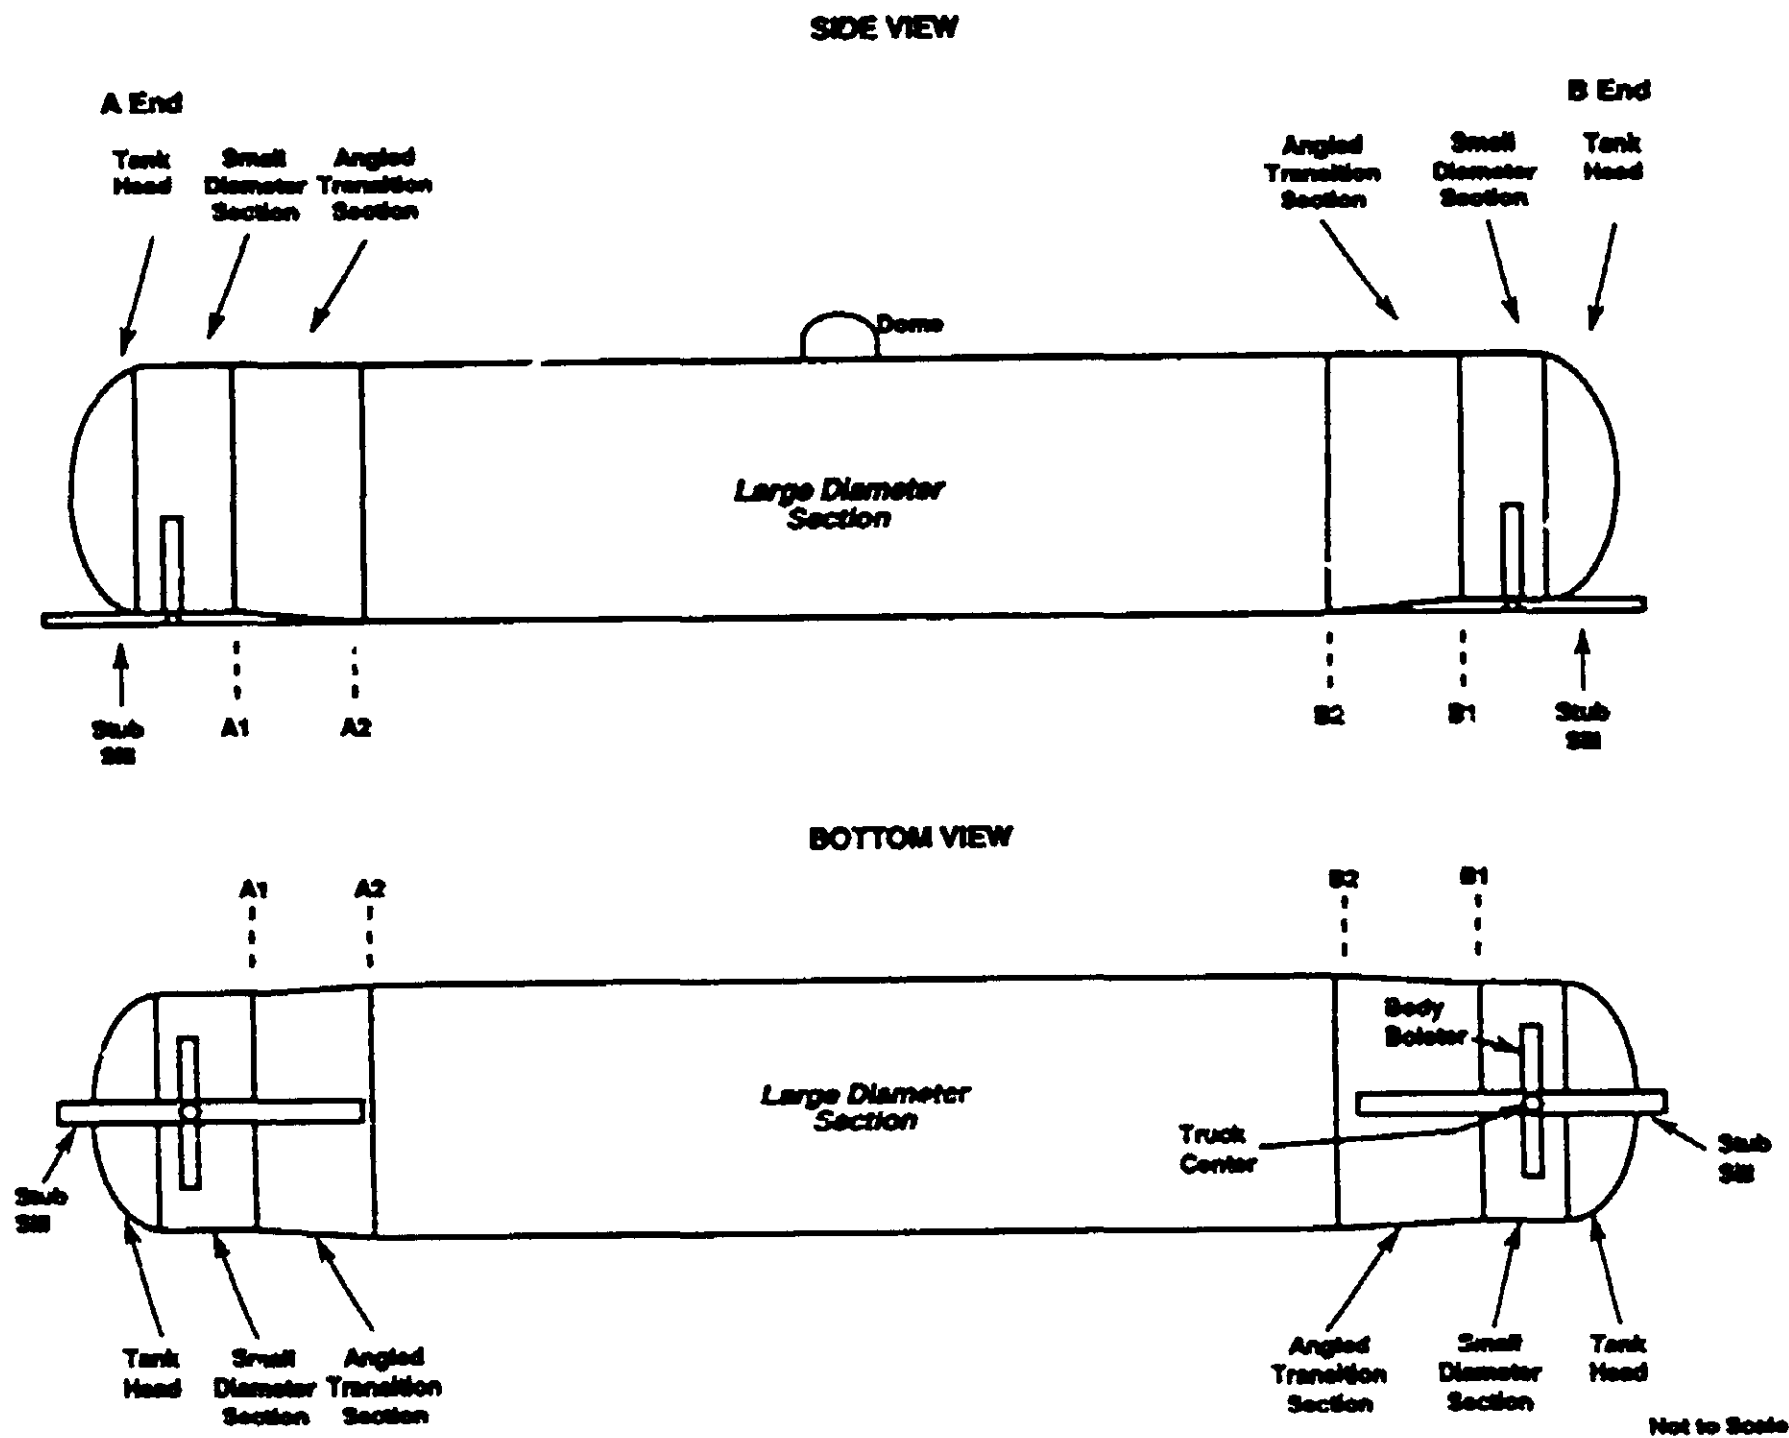
Figure 2—Bottom and side view diagrams of CONX 9101. A1, A2, B1, and B2 designate the circumferential welds in the tank at the A- and B-ends.

*Description of Structural Failure.*—The fracture and separation occurred along the outboard edge of the circumferential weld joining the large diameter section and the transition section for the A-end of the tank. Examination of the fracture surfaces on the tank shell disclosed a discolored crescent region that was about 21 inches long circumferentially and that was centered at the bottom centerline of the tank. Metallurgical examination at the Safety Board's materials laboratory showed that the discolored area of the fracture surface was extensively oxidized, which is indicative of long-term exposure to a corrosive medium and the presence of a preexisting crack. The extensive oxidization had obliterated the original fracture features. The preexisting crack was located longitudinally about 6 inches inboard (toward the center of the tank car) from the inboard end of the attachment pad for the stub sill (figs. 2 and 3) with initiation along the inside diameter surface of the tank at the weld/transition plate interface. Microscopic examination disclosed that the cracking occurred in the transition plate at and adjacent to the heat-affected zone from the weld. At its deepest point, the crack extended almost through the thickness of the transition plate (0.70 inch) before the circumferential separation occurred (fig. 4). Evidence indicated that the predominate growth of the crack was from the inside surface of the plate toward the outside surface. Within the fracture surface of the circumferential separation were many chevron markings in the overstress region, indicating that the fracture had stemmed from the preexist-

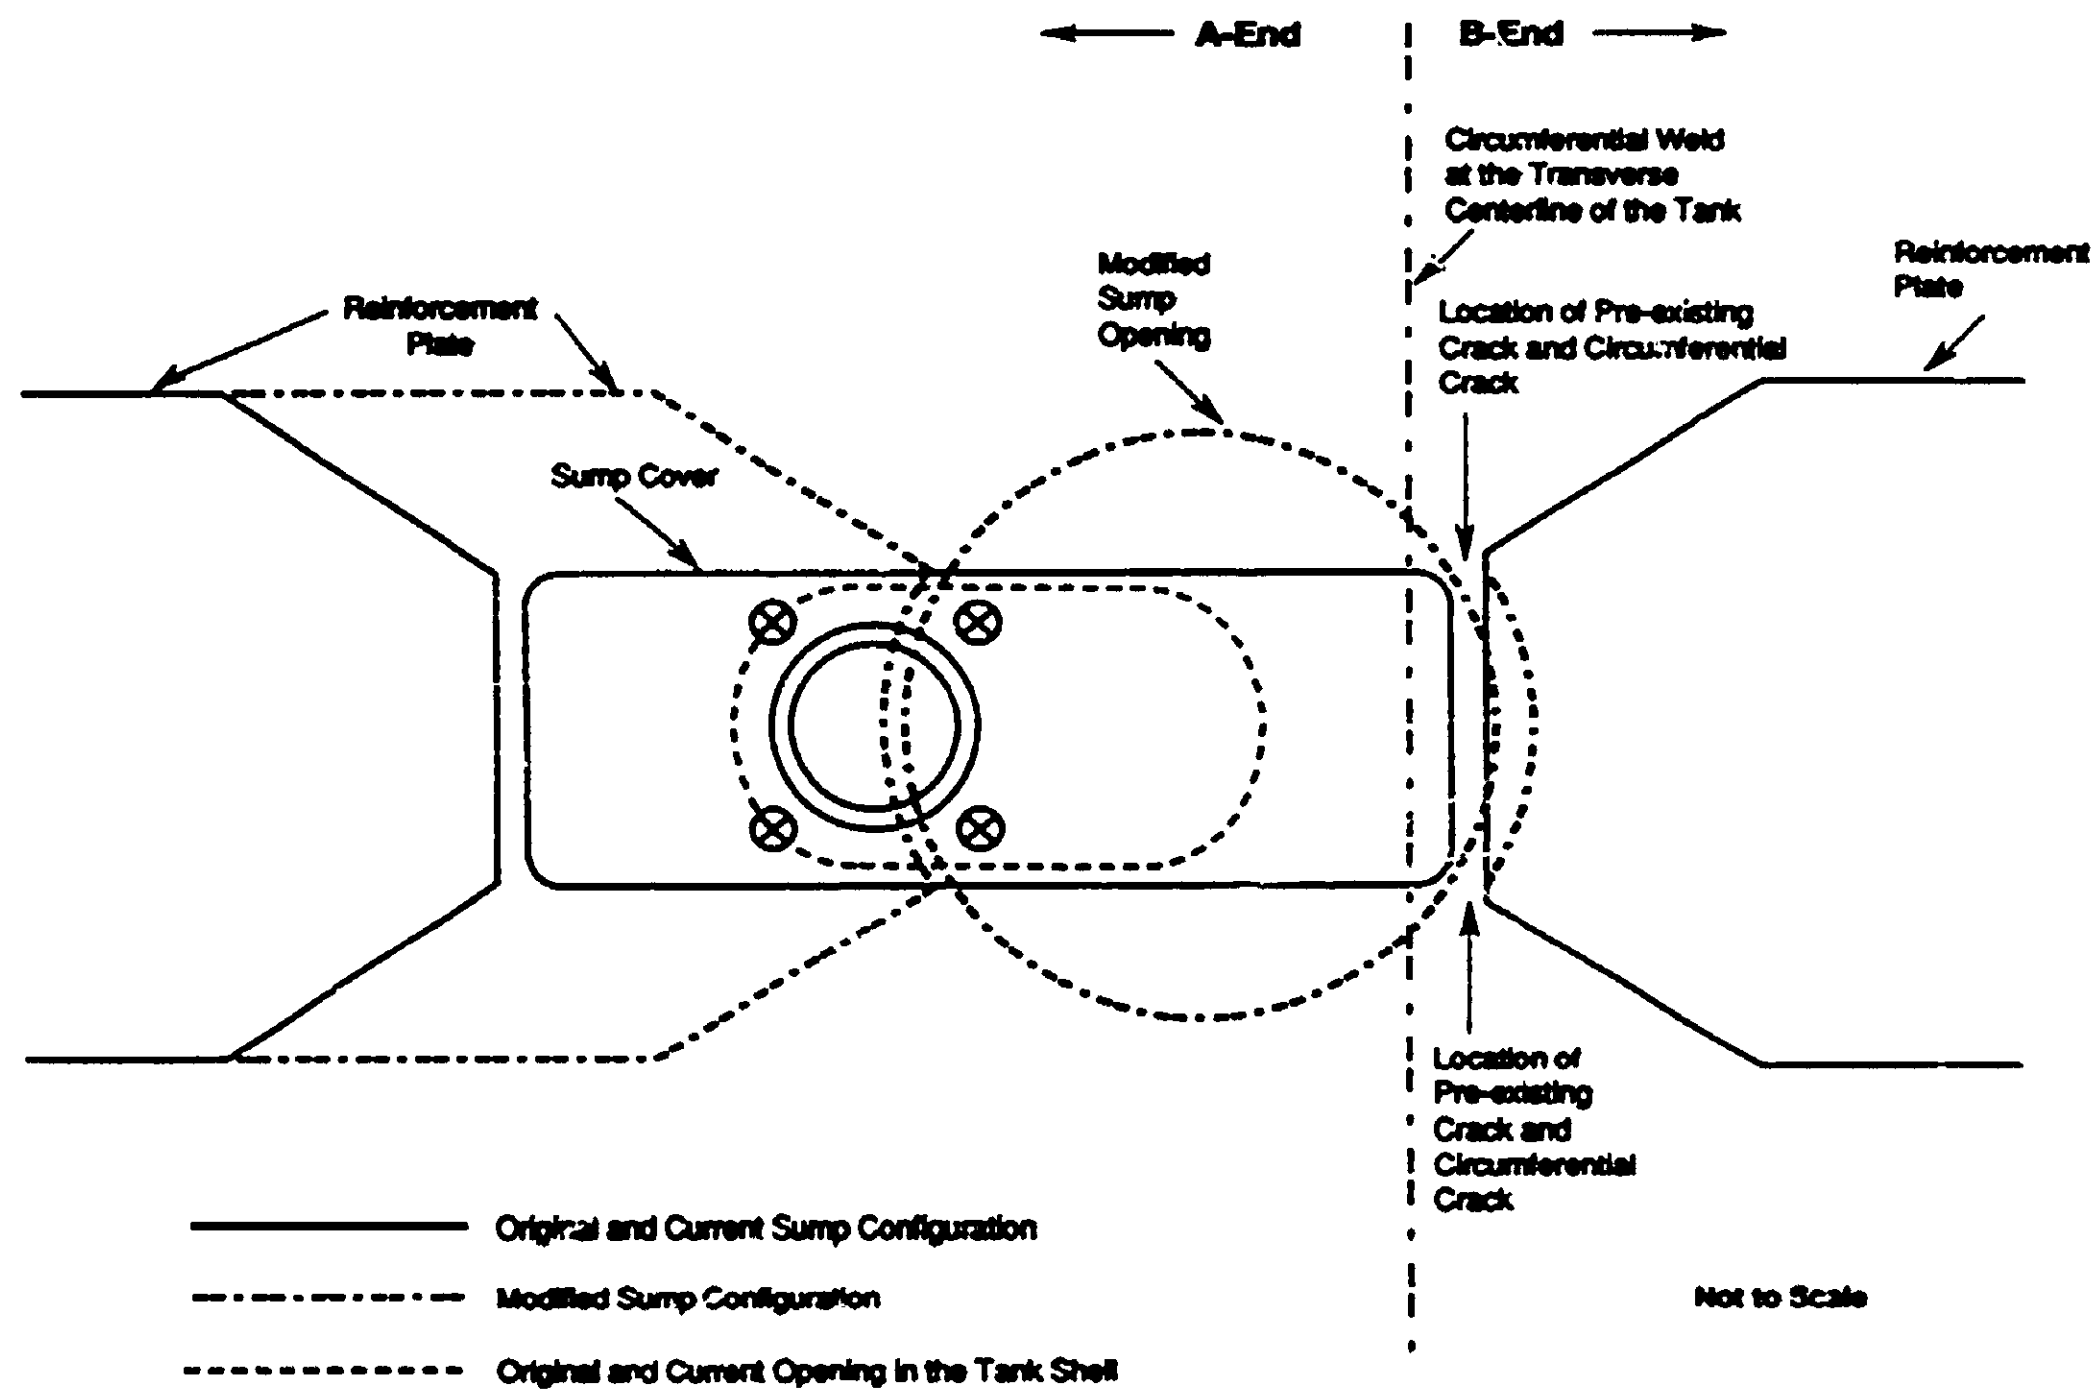
Figure 6—Past and current configurations of the sump area on UTLX 13835.

Union reassumed control of the five tank cars in 1986 and replaced the circular sump with a rectangular sump that was similar to that originally installed. To restore each tank car to its original configuration, Union removed the circular sump cover, repaired the 14-inch diameter hole in the tank, cut a new oval opening in the tank wall for the new sump, and then welded the rectangular sump cover across the circumferential weld at the bottom center of the tank car.

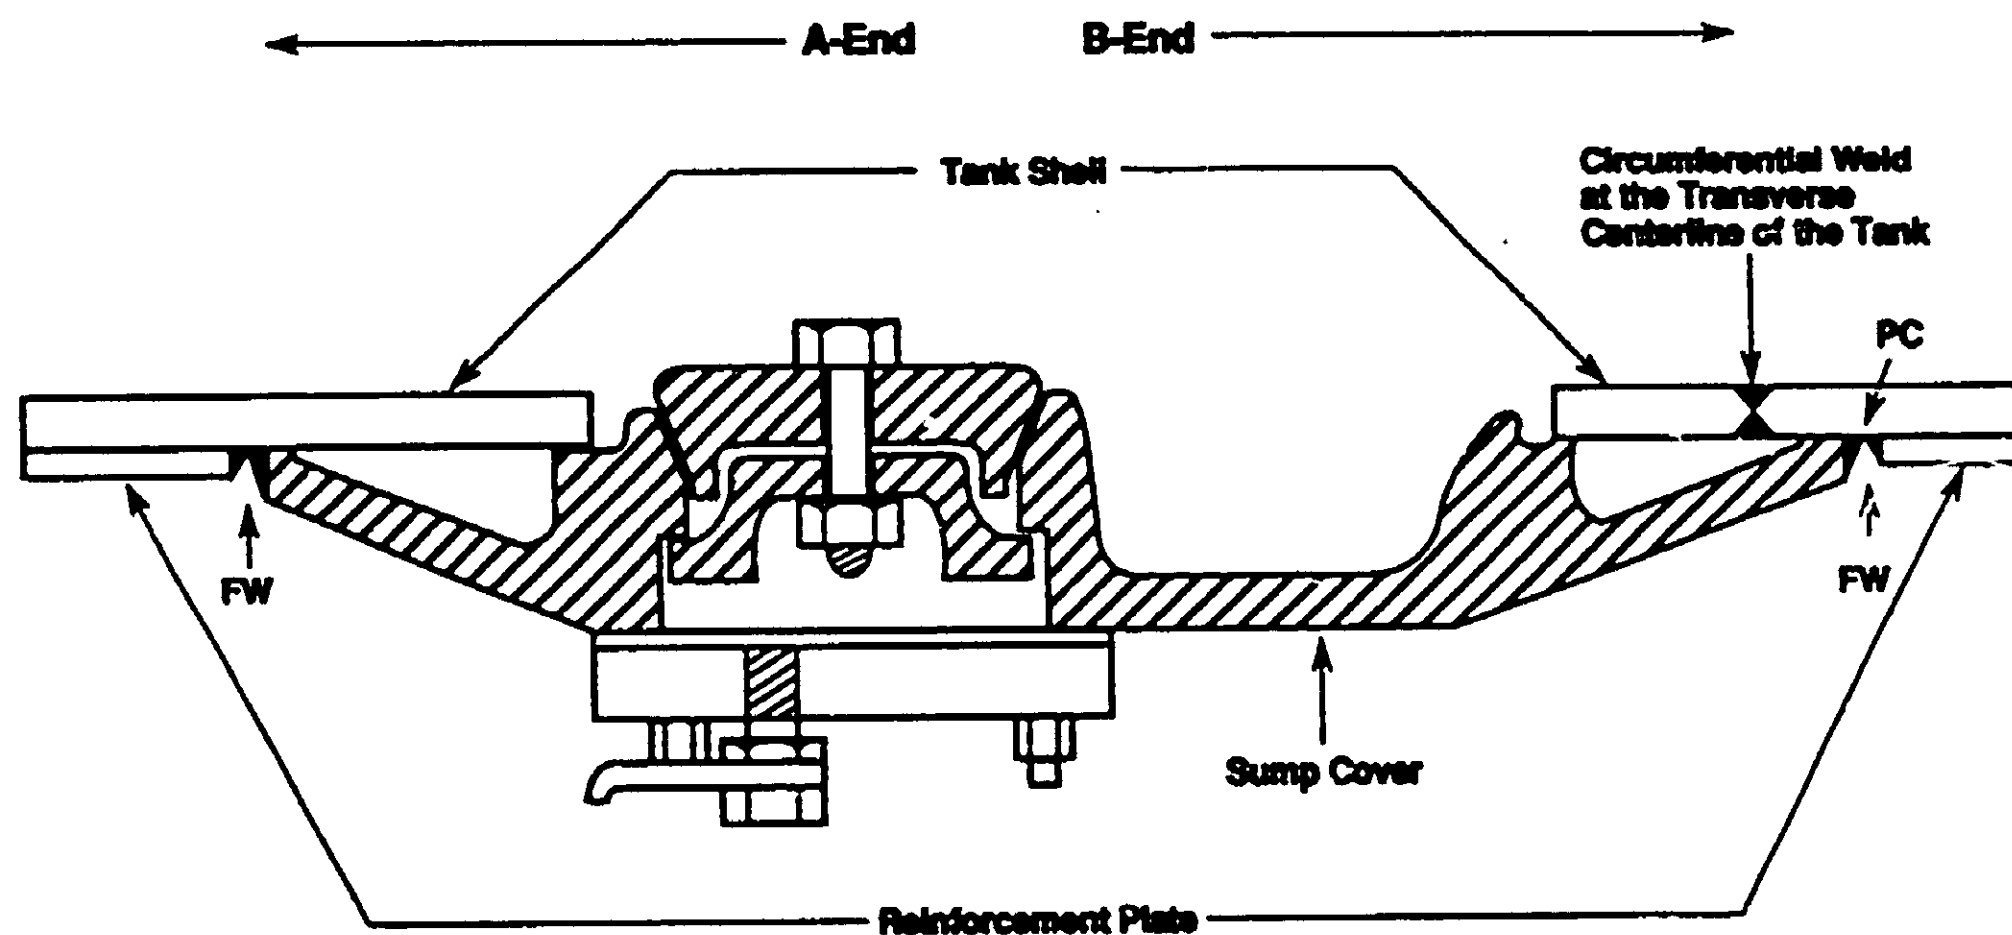
**FW – Fillet welds at locations that were required to have groove welds.**

**PC – Location of preexisting crack and origin of circumferential crack.**

**Figure 8—Cross sectional view of the sump cover on UTLX 13635. The design drawings indicated that the areas with fillet welds (FW) were to have groove welds. PC indicates the location of the preexisting crack and origin of the circumferential crack.**
